MEDICAL OFFICERS OF HEALTH, in the ordinary course of their daily duties, not unfrequently meet with examples of plumbing and drainage work which are ill-planned, or ill-executed, or both. Early in 1885 it occurred to me that if all such instances of bad work were briefly noted when observed, and a record kept of them, they would furnish interesting material for a column in some current publication, lay or professional. I accordingly printed a note in the *Health Journal*, a small monthly periodical till lately published by Mr. Heywood, inviting medical officers of health and inspectors discovering any defect in domestic sanitary fittings, drainage, or water service to write a description of the same, and send it, with a rough diagram, to me. My invitation was responded to, and thus, with instances of bad work communicated to me, and examples noted in my own district, I was generally able to find material enough to fill my column of "defects." In this manner ninety-one defects were described and illustrated in the pages of the *Health Journal*, many of my notes and illustrations being subsequently reproduced in other periodicals. These ninety-one examples of defective work, togethe

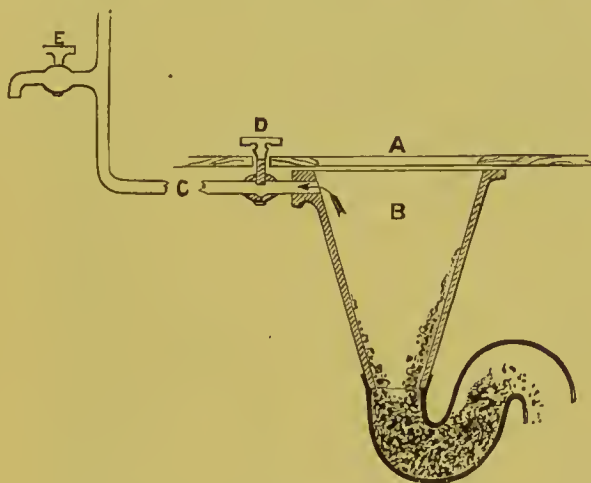
FIG. 56.

Fig. 56 is a section of a closet directly served from the main. A is the seat, B the basin, C the service pipe, D the screw-down tap on this pipe, and E the tap over the sink-stone, served from the same pipe. This arrangement was very common some years back, and though I have been long doing my utmost to get owners to provide closets with separate service cisterns, examples of the defect are brought to notice every month. When a single watercloset is flushed direct from the main the risk of fouling the town water (it may be with specific germs) is considerable, while

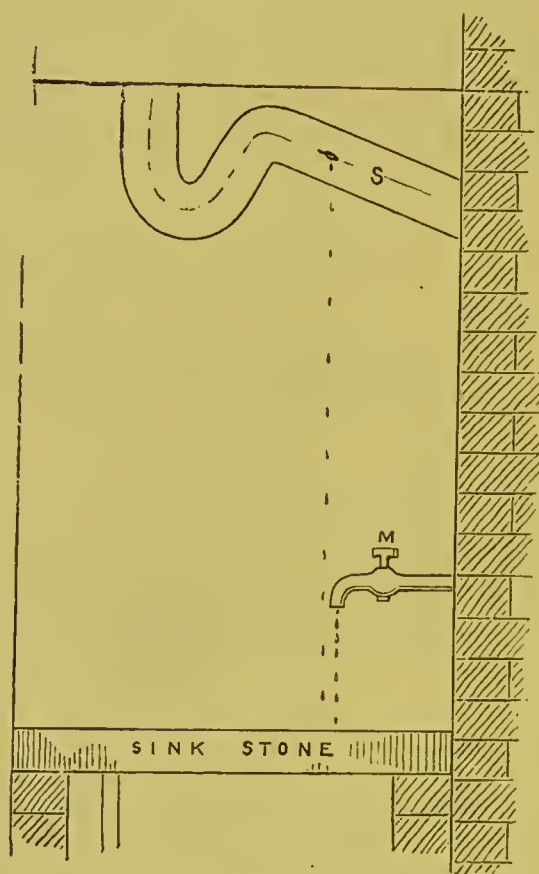
FIG. 57.

Fig. 57 is, I consider, one of the most interesting cuts in this series, and I desire to draw special attention to it. I received notice of a case of typhoid fever in a very old house in a poor neighbourhood. The patient was forthwith removed to the fever hospital, and the usual report as to the state of the premises was submitted to me. From the latter I

gathered that the house was dirty, and that there was a water-closet built out from the back wall, a separate service cistern for the same, and a pipe from the main for drinking and domestic purposes. Not satisfied with this report, I examined the premises myself. I found the closet was entered from a small landing on the stairs, between the ground floor and first floor. On looking to see what was under this (on the ground floor), I was surprised to find a sink-stone, and a tap from the main. Immediately over the sink-stone was the lead trap from the closet and a transverse portion of soil pipe connected therewith, which was carried through the back wall into the house. In the soil pipe close to the trap was a corroded hole, the position of this being shown in the cut. Through this hole foul gases must often have been discharged, and foul liquids from the closet must often have overflowed. Indeed, here were all the conditions present which one would expect to find resulting in an outbreak of typhoid fever. What in all probability happened is that drinking water drawn from the tap was polluted with excremental liquid dropping into it, and that water thus polluted was actually drunk. The illustration indicates how easily a jug of water drawn from the main tap M might be polluted by foul liquid running from the hole in the soil pipe S.

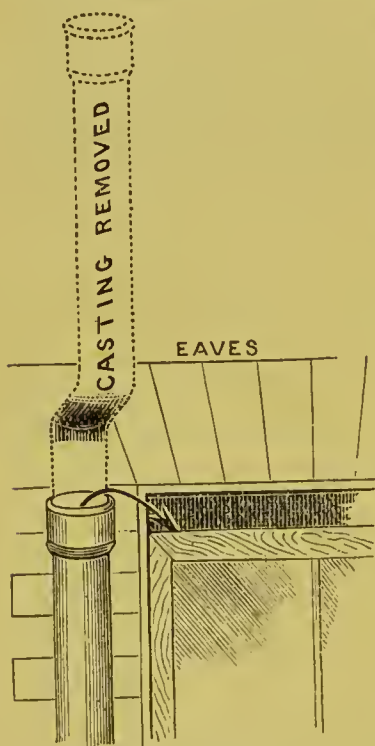
FIG. 58.

three inches at the top. The accompanying illustration (Fig. 58) explains itself.

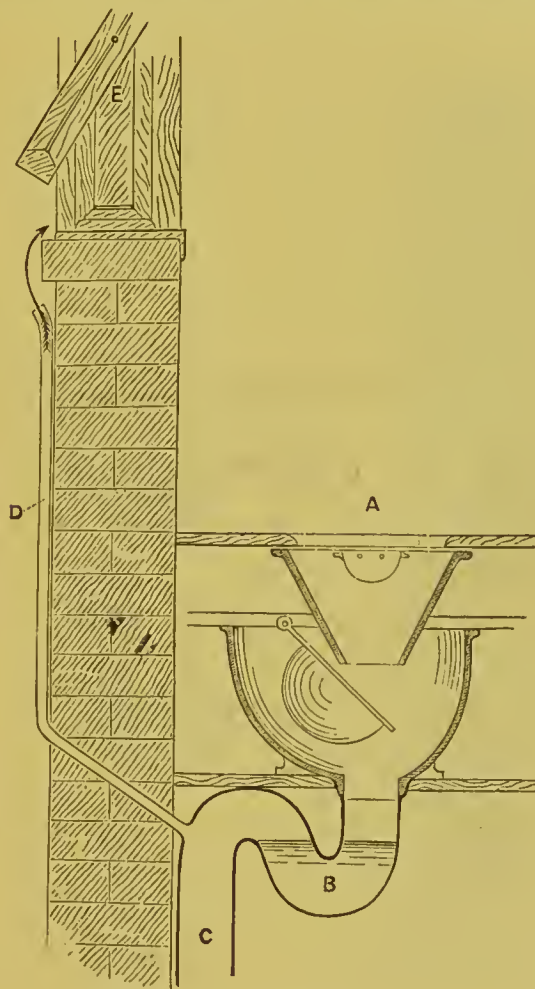
FIG. 59.

Fig. 59 represents an old pan closet which, although placed next an external wall, delivers into a soil pipe carried down inside the house. The closet A delivers into a lead syphon trap B, which is continuous with the soil pipe C. The soil pipe is connected with an earthenware pipe drain running under the

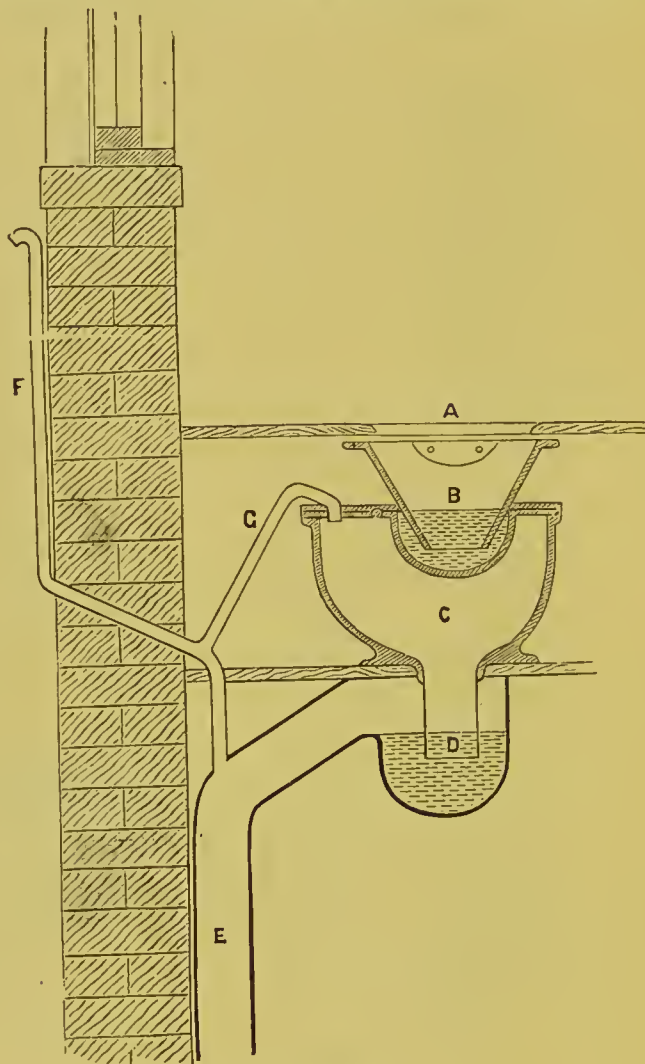
FIG. 60.

Fig. 60 explains itself. It gives a section of the closet fittings found in a large ecclesiastical residence, where what were alleged

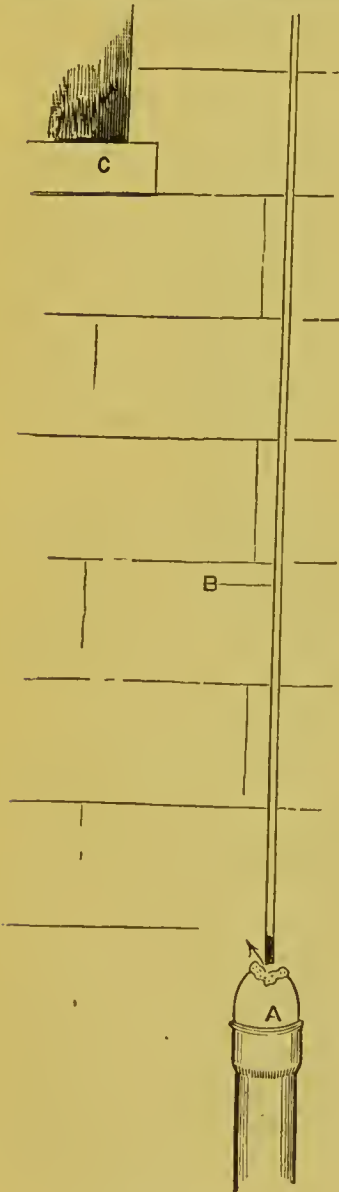
FIG. 61.

Fig. 61 shows a "ventilator" to a soil pipe which I discovered at a large suburban house. It was put up with the approval of the local surveyor and medical officer. A 4in. lead soil pipe was brought through the wall and efficiently connected with an iron soil pipe. A large hole had then been made in the lead at the top, and a $\frac{1}{2}$ in. iron pipe connected to this hole with putty. The iron pipe was quite closed up at the lower end with rust, &c., and was just too short to meet the lead pipe. Through a large hole in the lead and putty, effluvia ascended to the window 5ft. above. A is the lead pipe, B the "ventilator," and C the window.

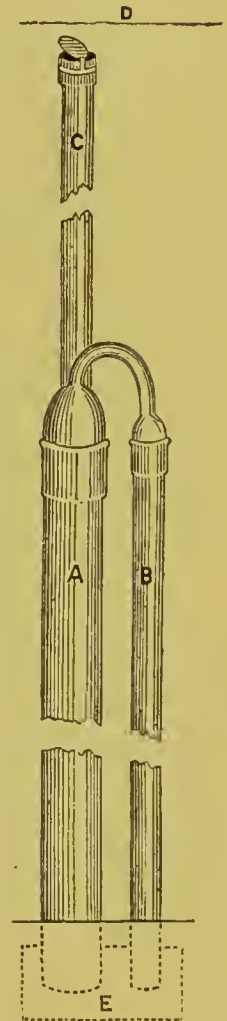
FIG. 63.

Fig. 63 shows how the soil pipe and bath waste in a large semi-detached house were brought down from an upper storey and ventilated. The 4in. iron soil pipe was ventilated with a 2in. iron pipe, terminating just under the roof eaves, and capped with a little metal top, as if purposely to direct any foul air emitted towards a window a few inches off. The 2in. iron bath waste came out by the side of the soil pipe, and was connected with it (for what purpose I know not) by a lin. lead pipe, as shown. A is the soil pipe, B the bath waste, C the soil pipe ventilator, D the roof eaves, and E the chamber into which soil pipe and bath waste delivered, and through which the contents were transmitted to the 6in. pipe under the house. Taking a soil pipe and bath waste out separately, and afterwards connecting them together, above and below, seems an unusually ridiculous proceeding.

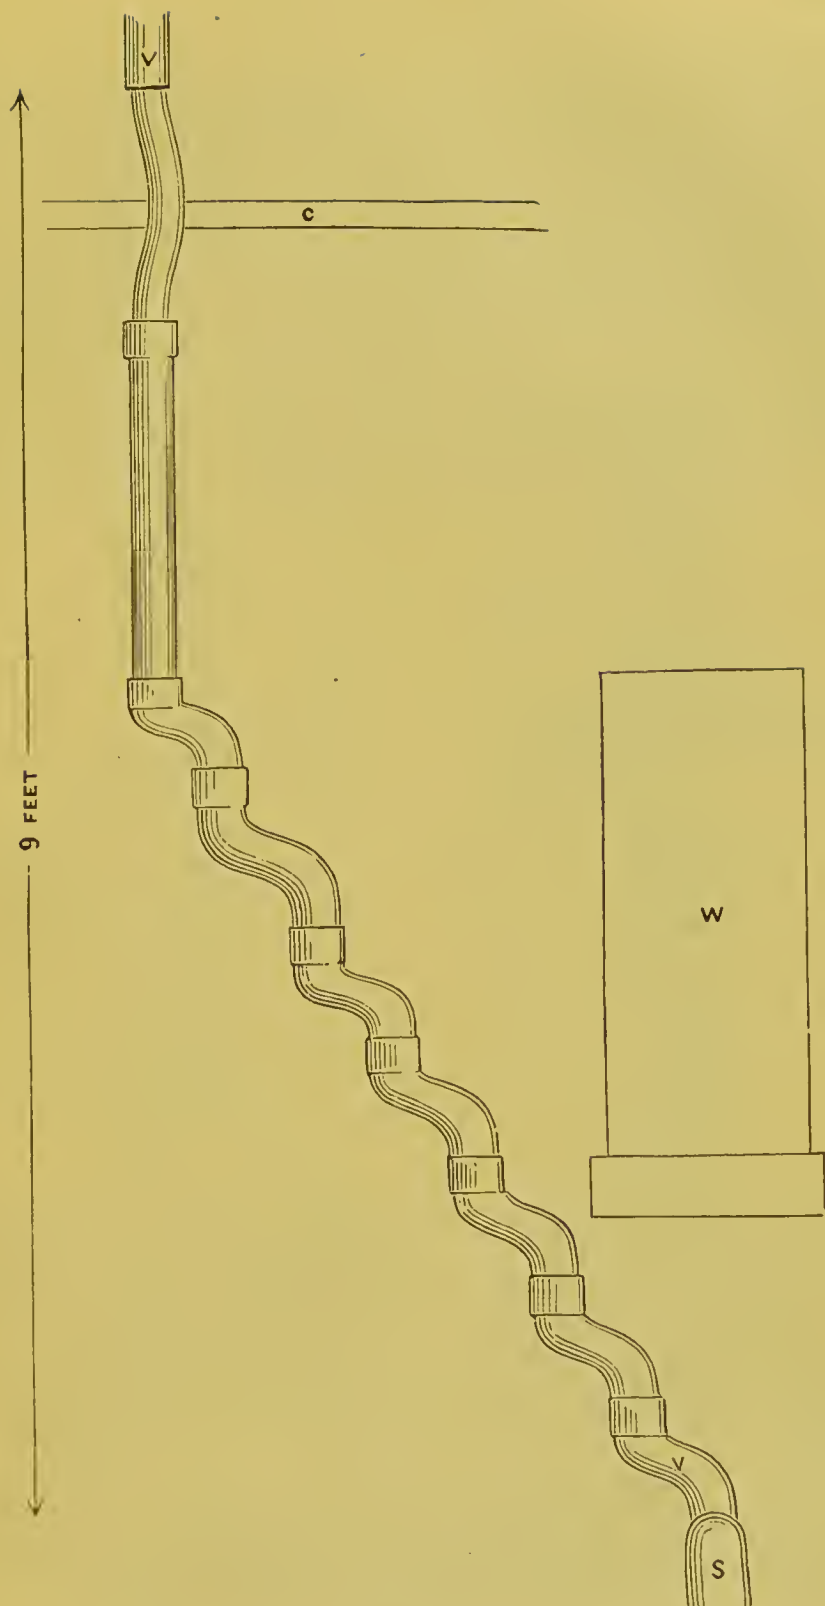
FIG. 64.

A correspondent has kindly drawn my attention to a soil pipe ventilator which is certainly noteworthy. Such an unworkman-like contrivance I hope and believe is not common. (*Vide* Fig. 64, which is carefully drawn to scale.) W represents the window

of a closet, and S the lead soil pipe from same. Jointed to this was an iron pipe casting, which carried the ventilator up nine inches; and next to this came a second, third, and fourth casting of the same size; and then three more castings similar in shape and averaging the same length. Above this was $2\frac{1}{4}$ ft. of iron pipe, then the rain gutter C had to be "jumped," and there was a further length of about 8 ft. of iron pipe, the ventilator terminating a few inches above the top of the gable. It will thus be seen that the ventilator VV, in ascending 9 ft., had no less than ten joints. It is not likely that all these joints were tight in the first instance, and quite impossible that they would remain so after the expansions and contractions of a few summers and winters. Two windows, one above the other, to the left,

were in close proximity to these joints. It is to be noted that while the soil pipe is 4 in. in diameter the curved castings are 3 in. pipes, and above a smaller diameter pipe is used. My correspondent remarks that the plumber responsible for this work was probably uninformed on the subject of resistance to air currents by friction, and that he sacrificed efficiency to a taste for ornamental device and the desire to sell as much piping as possible.

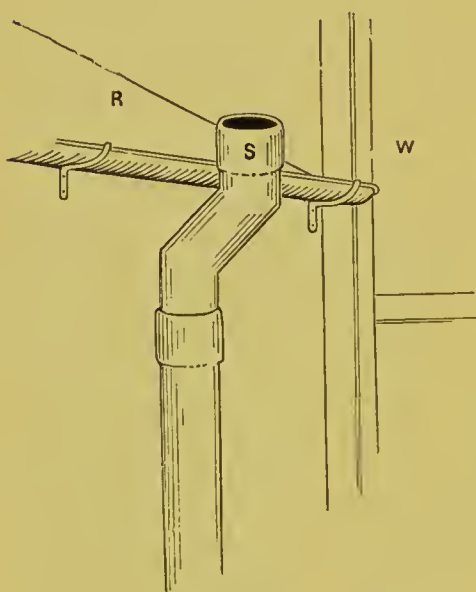
FIG. 65.

Fig. 65 indicates yet another way in which soil pipes are deliberately ventilated into bedrooms. The defect was noticed in several newly-built houses forming one side of a main street. A portion of each house projects into the yard, and is one storey lower than the rest of the building. These portions contain the

closets. The soil-pipe ventilators should, of course, have been taken up 2ft. or so above the eaves of the roofs of the main buildings. As it is, however, the ventilator has, in each instance, been carried just above the gutter of the lower roof, and terminates close to a bedroom window, as shown in the illustration. R is the lower roof, S the soil pipe ventilator, and W the window.

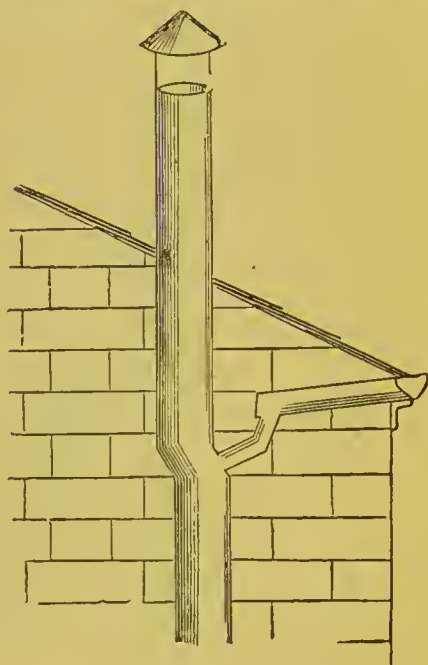
FIG. 66.

Fig. 66, from a correspondent, represents a soil-pipe ventilator into which the rain is conducted. The trapped bath waste and overflow, as well as the rain pipe, are connected with what is

intended as a ventilator to the soil pipe; but as this is sealed at its base by the contents of a syphon trap, the soil pipe is really unventilated. A pipe such as this, remarks my correspondent, is expected to convey rain and waste water downwards and a current of air upwards, and this occasionally at one and the same time, the effects of the compression of the contained air below the points of discharge, and of syphoning and trapping water, not being apparently considered. Ventilators as described

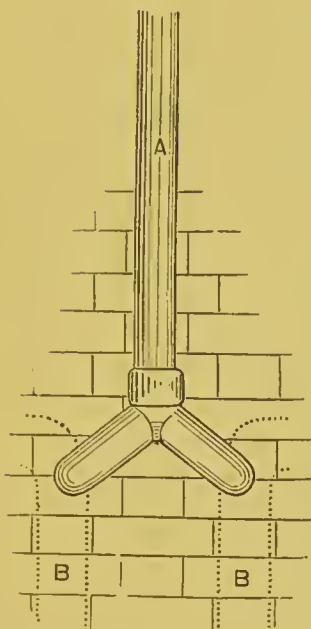
FIG. 67.

Fig. 67 represents two soil pipes built into the wall, and ventilated in a novel way. A pair of semi-detached villas had closets in the front, on the first floors over the lobbies. The soil pipes coming very near the surface of the wall on the inside were covered by about an inch of plaster; and in one villa the staining of this plaster and an effluvium nuisance gave indications of a leak. On calling at the villas with reference to this nuisance, the first thing noticed was the iron ventilator as shown which was connected with both soil pipes. It was not ill-fitted, and was carried up 9in. above the roof eaves. If a stoppage had occurred in either of the soil pipes, the contents would probably have overflowed into the common ventilator and choked it. A indicates the ventilator, B and B the two soil pipes.

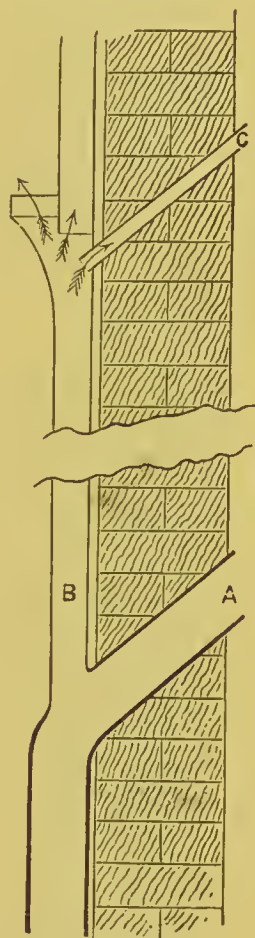
FIG. 68.

Fig. 68 represents an ingenious device for ventilating a soil pipe into a bedroom. Offensive smells in the bedroom were noticed and complained of. On inspection it was found that there was an open cistern in the bedroom, and that the overflow pipe from this was carried into the rain spout, which was made to act as a soil-pipe ventilator. A is a 4in. soil pipe taken out direct from a closet, B is a 2½in.

part of the foul air from the soil pipe was conveyed up the overflow pipe into the bedroom, part ascended the upper portion of the rain spout to the roof gutter, where a portion got in under the slates, and part was delivered externally to be drawn in at contiguous windows when open.

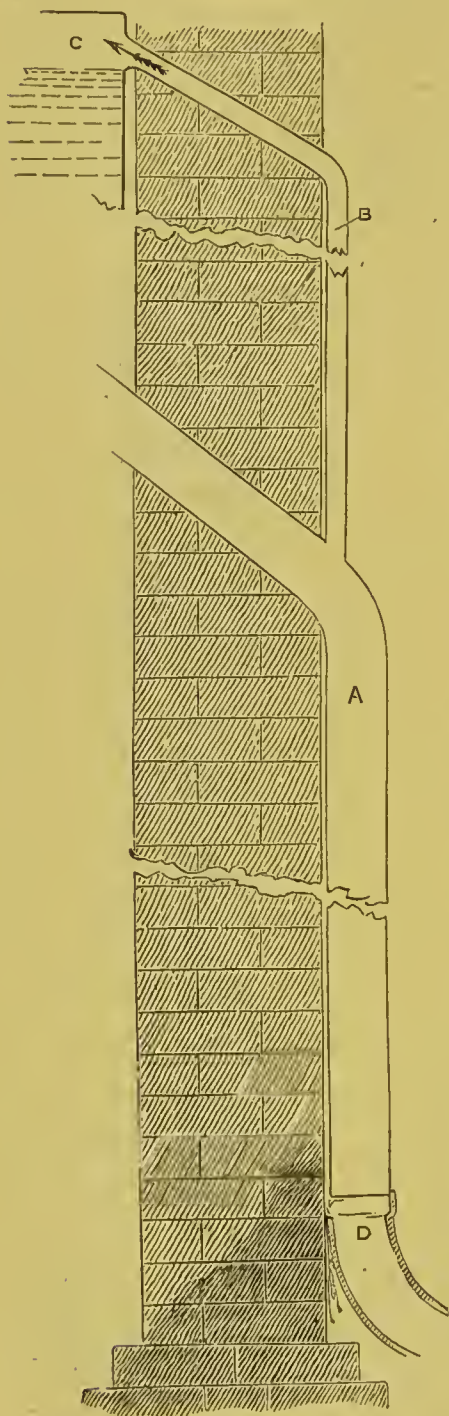
FIG. 69.

A correspondent sends me a sketch and description of a defect which he recently saw in an old house. (*Vide* Fig. 69.) Here is an unventilated soil pipe taken outside directly it leaves the watercloset, and as there is no proper connection between the soil pipe and house drain, filth is allowed to escape into the

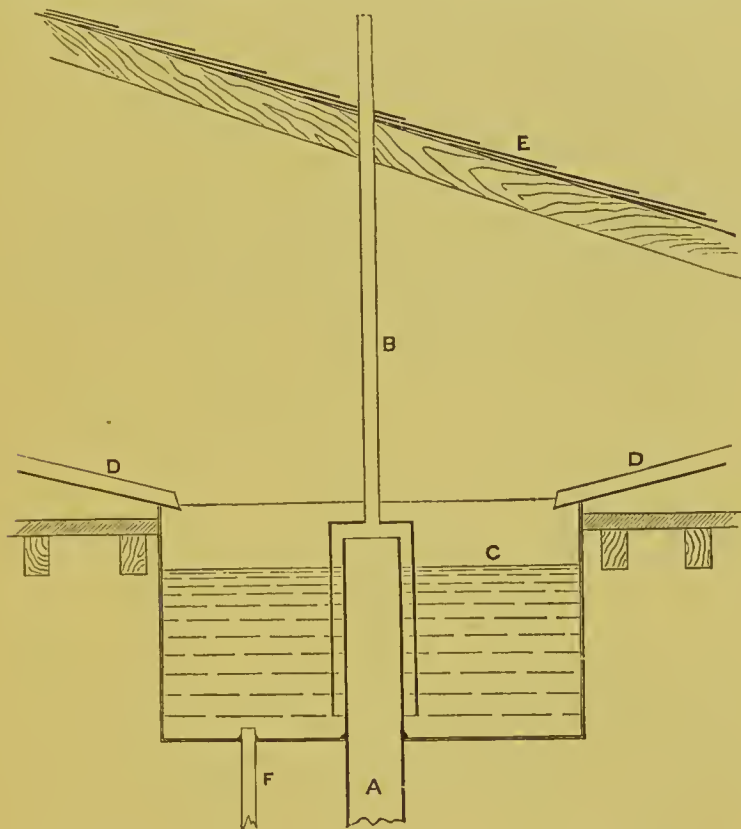
FIG. 70.

Fig. 70 represents part of a series of defects found in each of fifteen suburban residences, erected about twelve years ago. The soil pipe, of 4in. cast-iron pipes, was carried up through the bottom of the rain-water cistern to within two or three inches of the top, and made to act the part of overflow for the cistern. This is marked A in the cut. A zinc cap, in diameter two inches larger than the soil pipe, was placed in position over the end of this pipe, as a bell over a sink pipe. A zinc pipe B, an inch in diameter, was soldered round a hole at the top of the zinc cap, and the upper extremity continued above through the roof E, as shown. C is the rain-water cistern for flushing the closets, D and D the gutters from the roof, and F the flush pipe. As the soil pipe was directly connected with the main sewer, and the closet, soil pipe, and cistern were situated in the centre of the house, with no ventilation to the closet, sanitary arrangements could scarcely have been more defective. There were, however, houses in the same district in which the soil pipes were found continued upwards into the cisterns, and where not even one inch ventilators had been provided.

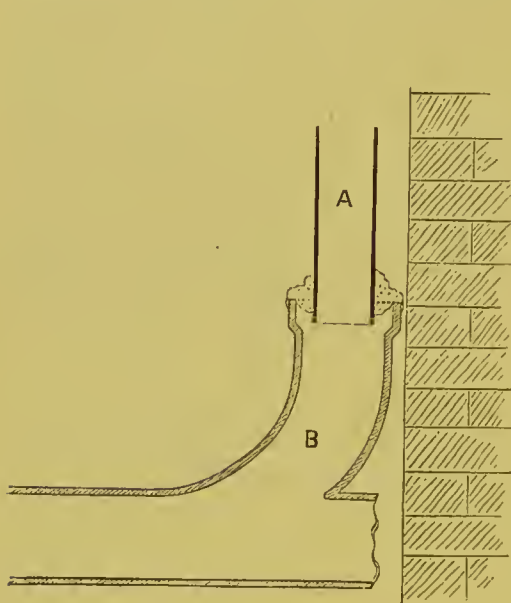
FIG. 71.

Fig. 71 represents a manner of connecting the soil pipe to the drain which I hope is exceptional in any town. To me it was certainly a new experience. Complaint was received of an effluvium nuisance in the front parlour of a small semi-detached villa, rented at about £20. On examination it was found that the soil pipe, which received also the bath waste, was carried into a 6in. earthenware junction pipe. The straight end of this pipe had been broken off in order to make it come close enough to the wall, and the broken end was *not stopped*. Of course, foul water penetrated through the wall just above the footings into the space beneath the parlour joists. A is the soil pipe and B the junction pipe.

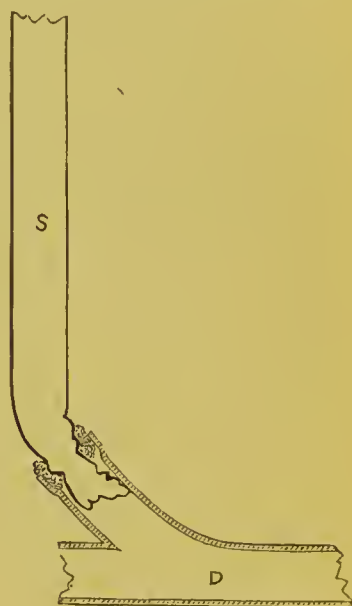
FIG. 72.

Fig. 72 shows a lead soil pipe S connected by a junction pipe D to the house drain. Instead of making a proper joint the workman had crumpled up the end of the soil pipe, and roughly thrust it into the pipe anyhow. It was cemented round, so that the joint did not actually leak, but at the joint the capacity of the soil pipe was reduced from being 4in. in diameter to being scarcely 2in., thus preparing the way for a stoppage sooner or later.

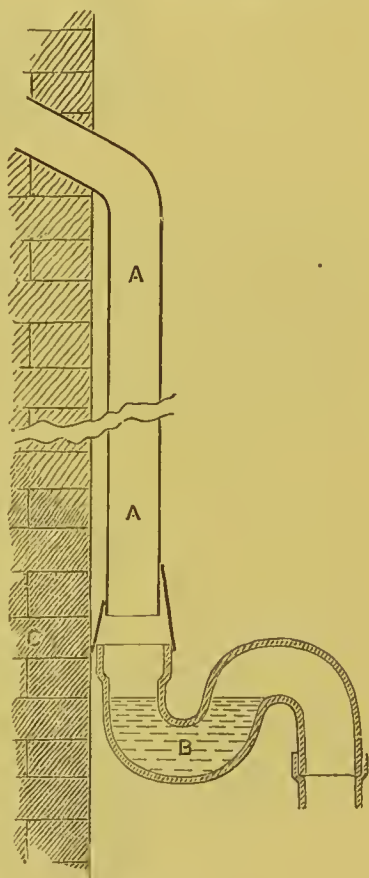
FIG 73.

Fig. 73 was sent by a correspondent in one of the largest towns in the kingdom. It represents an unventilated soil pipe, imperfectly connected with the trap at the foot. The connection consisted of four slates laid round the end of the soil pipe and trap. The result was that the contents of the soil pipe soaked into the ground and the contiguous portion of the wall, causing an effluvium nuisance inside the house. A indicates the soil pipe, B the trap, and C the saturated portion of the wall. Here

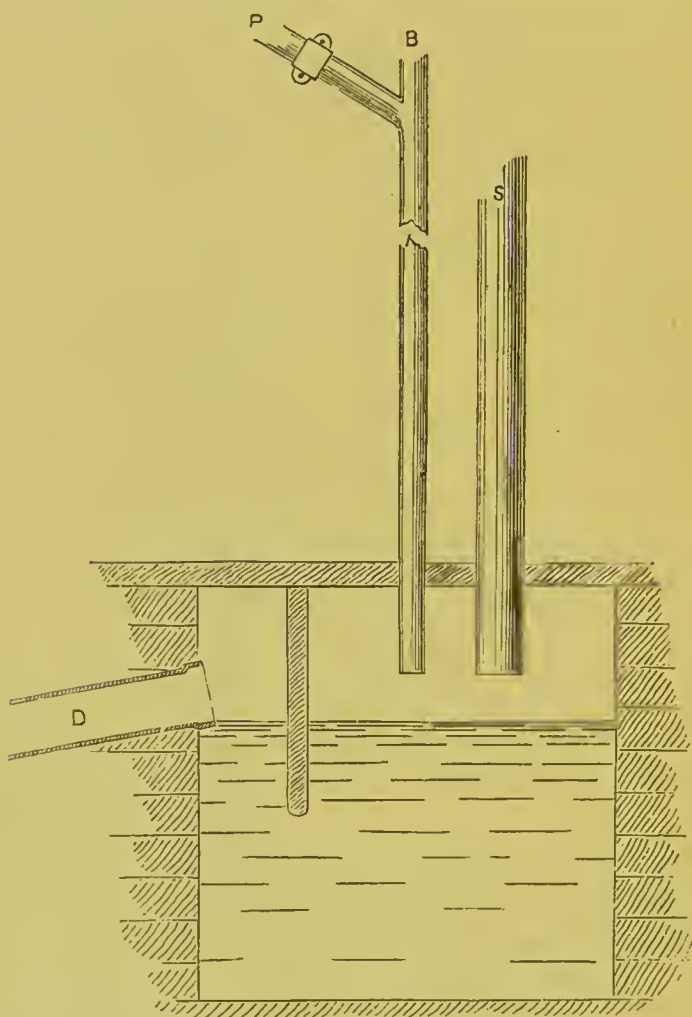
FIG. 74.

Fig. 74, received from a correspondent, is rightly described by him as a foul-gas generator. It represents a soil pipe S, and a waste pipe from pantry sink and bath, P and B, delivering into a covered pit measuring $2\frac{1}{2}$ ft. by $1\frac{1}{2}$ ft. and $2\frac{1}{2}$ ft. wide, and furnished with a mid-feather and outlet D, as shown. This arrangement was provided at a large house, and the workmanship was excellent though misapplied. The object of such a pit is merely to break the connection between the house and the public sewer, which can be done in a much more simple way, but what it actually becomes is a tank for intercepting the solids brought down by the soil pipe, and this is stirred up from time to time by the warm water discharged with considerable force from the pantry sink and bath.

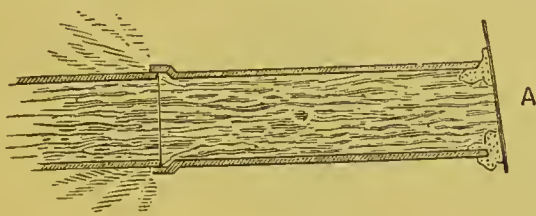
FIG. 75.

Fig. 75 illustrates the cause of a nuisance in a suburban villa. On inspection it was found that the 6 in. drain from the closet came to an abrupt termination close to the garden wall dividing this property from the next. The end of it had been deliberately closed up as shown at A, and the drain was full and leaking at some of the joints. A reference showed that two villas were built at the same time, and were allowed to drain together to the same sewer in front. Subsequently the villa in which the nuisance occurred was sold, and the other remained the property of the builder. It seems probable that about the date of the sale the vendor must have severed the drain from the villa he was selling, and reserved the drain running down his garden for the exclusive use of his own villa. A similar case was brought under my attention some time since. A drain serving two adjoining houses became frequently choked, and the tenants quarrelled about the payment of the charges made for cleansing it. Eventually the tenant of the garden in which the drain was situated cut off his neighbour's drain. Here, however, the disconnection was done openly and avowedly, and no attempt was made to close the end of the pipe, so that the resulting nuisance was manifest, and a separate drain was provided without delay.

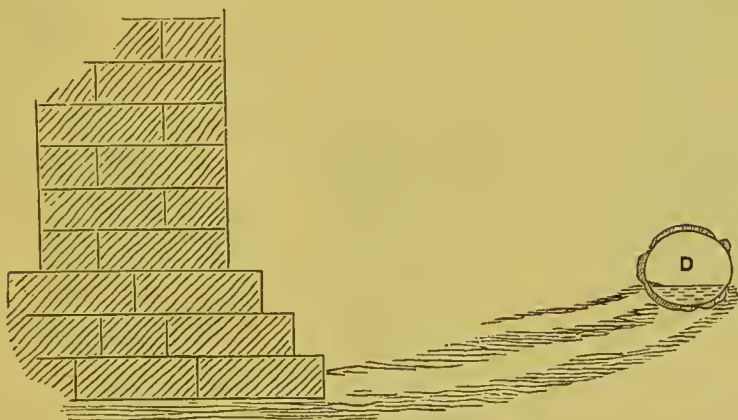
FIG. 77.

Fig. 77 shows a small portion in elevation. The horizontal line at the top indicates the level. Pipe A and the next to the left were about the fall intended, pipe B was dead level, pipes C and D were at different inclinations, the fall in both instances being the wrong way; beyond was a pipe with a slight inclination in the right direction. The joints were, almost without exception, imperfect, some allowing the contents to escape freely.

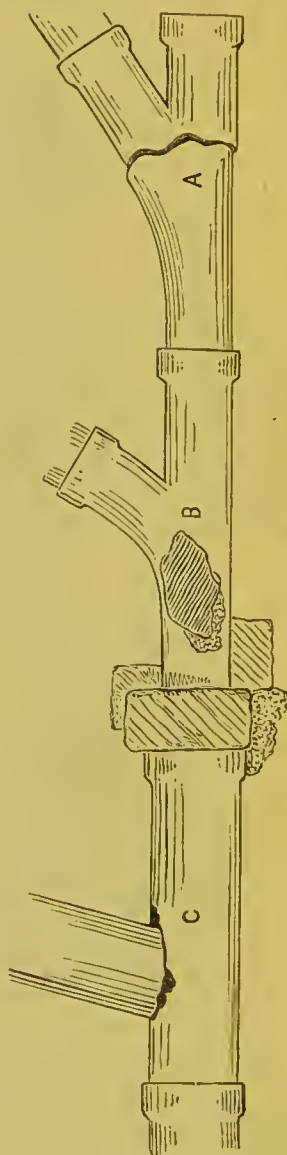
FIG. 78.

Fig. 78 shows another small portion. It will be noticed that two pipes are placed with the plain ends together, leaving an open joint at A, and the flange is broken off the pipe at B. Many of the flanges were found to be broken, and plain ends were placed together at two or three points.

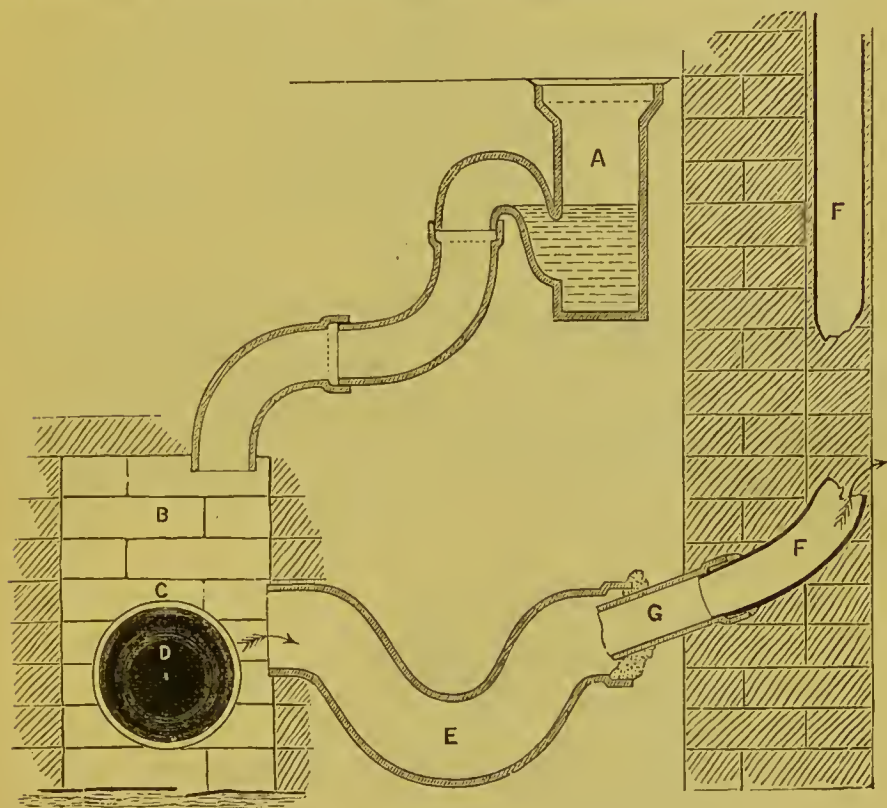
FIG. 80.

Fig. 80. A gully trap A, on which a waste pipe delivered, was brought into a cesspit B, loosely made with brick sides and a broken slate bottom; a 6in. earthenware pipe, as shown at E,

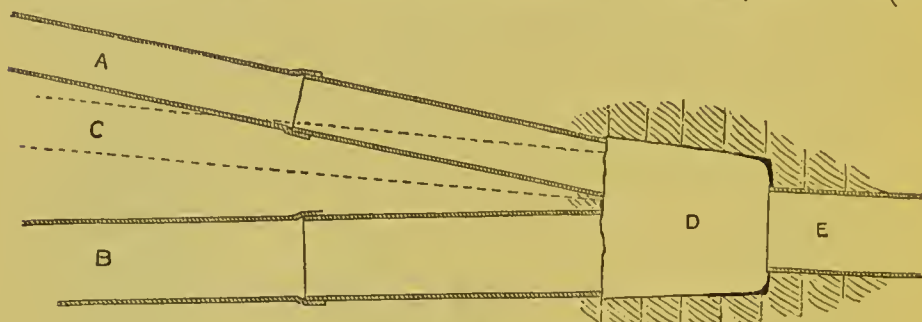
FIG. 81.

Fig. 81 represents defects in the drains in the basement of a large house I recently examined. A and B are glazed earthenware pipe drains, carrying slop water, and these, with C (an

old land drain just below A), are made to deliver into a small chamber D, and thence through the glazed earthenware pipe E. Drains should not be laid in the basement of a house, even if they only carry slop water. In this instance the joints were defective, and the flanged ends of the pipes all directed towards the outfall. However, the special defect to which attention is drawn by this illustration is connecting a land drain, roughly

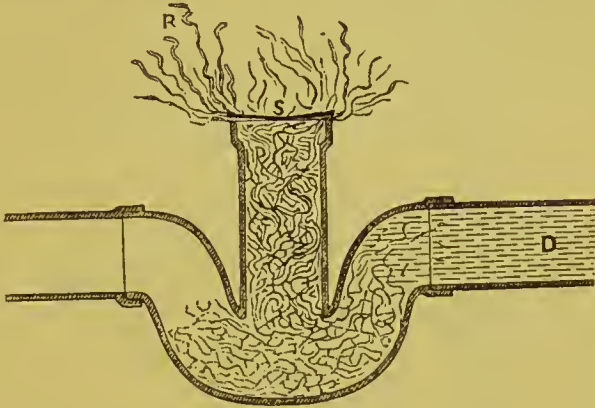
FIG. 83.

Fig. 83 represents the cause of a stoppage in a 6in. glazed earthenware pipe drain from a large house. The drain was laid

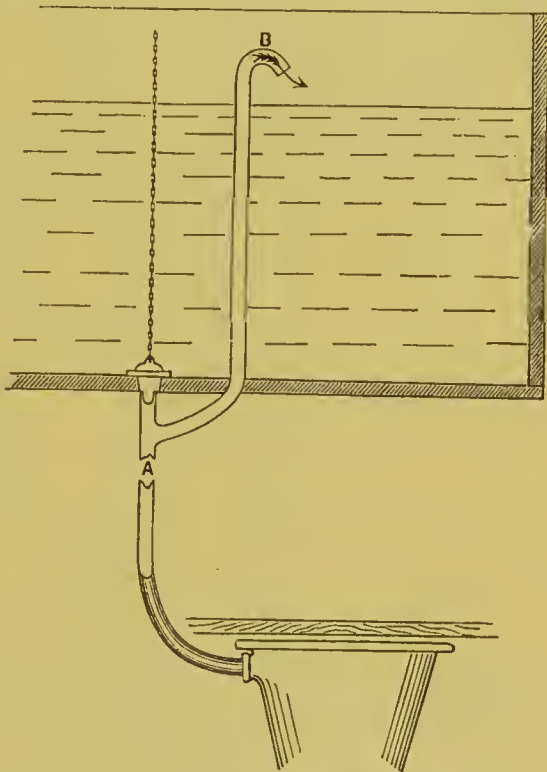
FIG. 97.

Fig. 97 represents a portion of the interior of a terra cistern, the overflow pipe from which is carried directly into the drain. Connecting the cistern overflow to a drain is, I regret to say, a

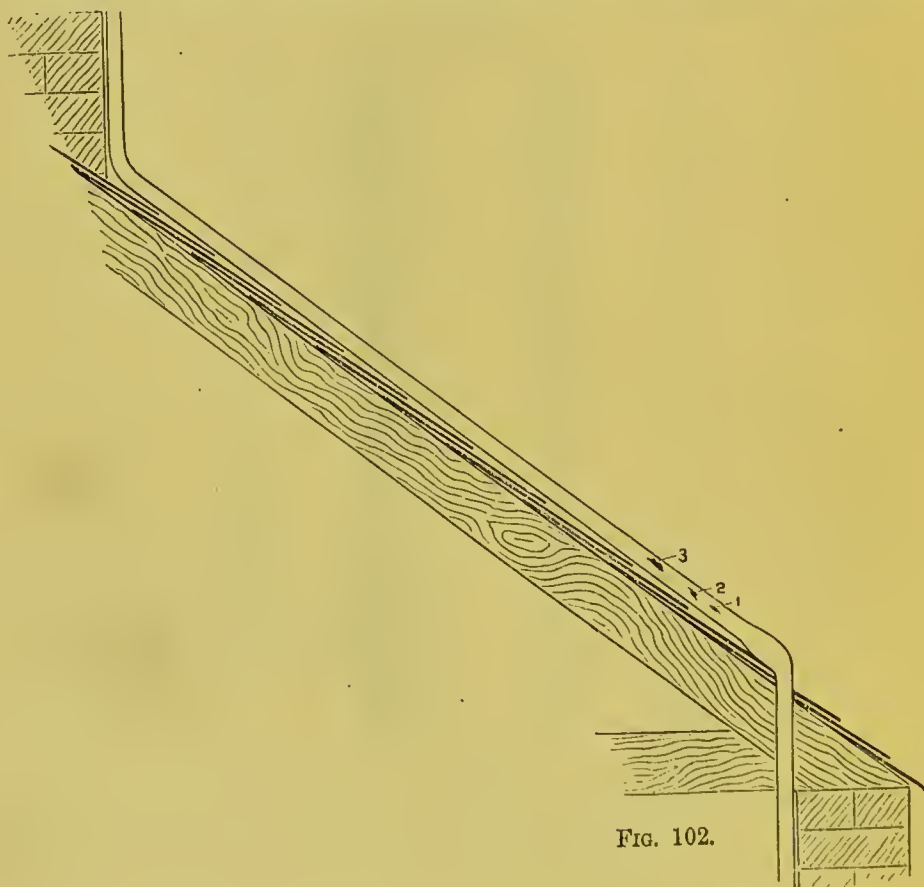
FIG. 102.

The next illustration, Fig. 102, shows the expansion pipe from a hot water cylinder, which was ruptured by frost three times between Christmas and the middle of January. Every plumber knows that an expansion pipe should not be exposed to the action of frost, yet the pipe shown was carried along the roof, unprotected for five feet, and then up a chimney for four feet. Just beyond the point where it pierced the roof there was a joint, and the first rupture occurred close to this at 1. After it was mended, a second rupture occurred at 2; and after this was mended, the pipe burst for the third time at 3. The

chimney was from a kitchen, and was practically always warm, and if the pipe, instead of being carried along the slates, had been made to pierce the roof where the chimney came through, it would have been efficiently protected from the action of frost.
